What every sailor needs to know about seacocks

Thousands of yachts, including new ones, are in danger of sinking, due to through-hull fittings made from brass rather than bronze. Yacht surveyor Paul Stevens, explains how confusion in some chandleries could put your boat at risk

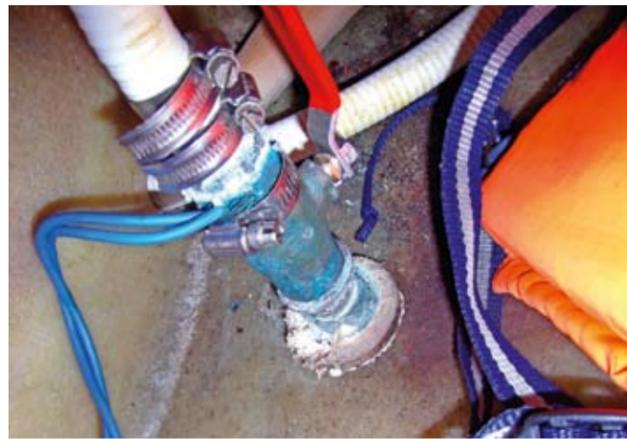
2009 boat: through-hull already showing the pinkish spots of classic dezincification

Time to panic! So much electrolytic action that the plywood backing pad is disintegrating due to electrochemical decay

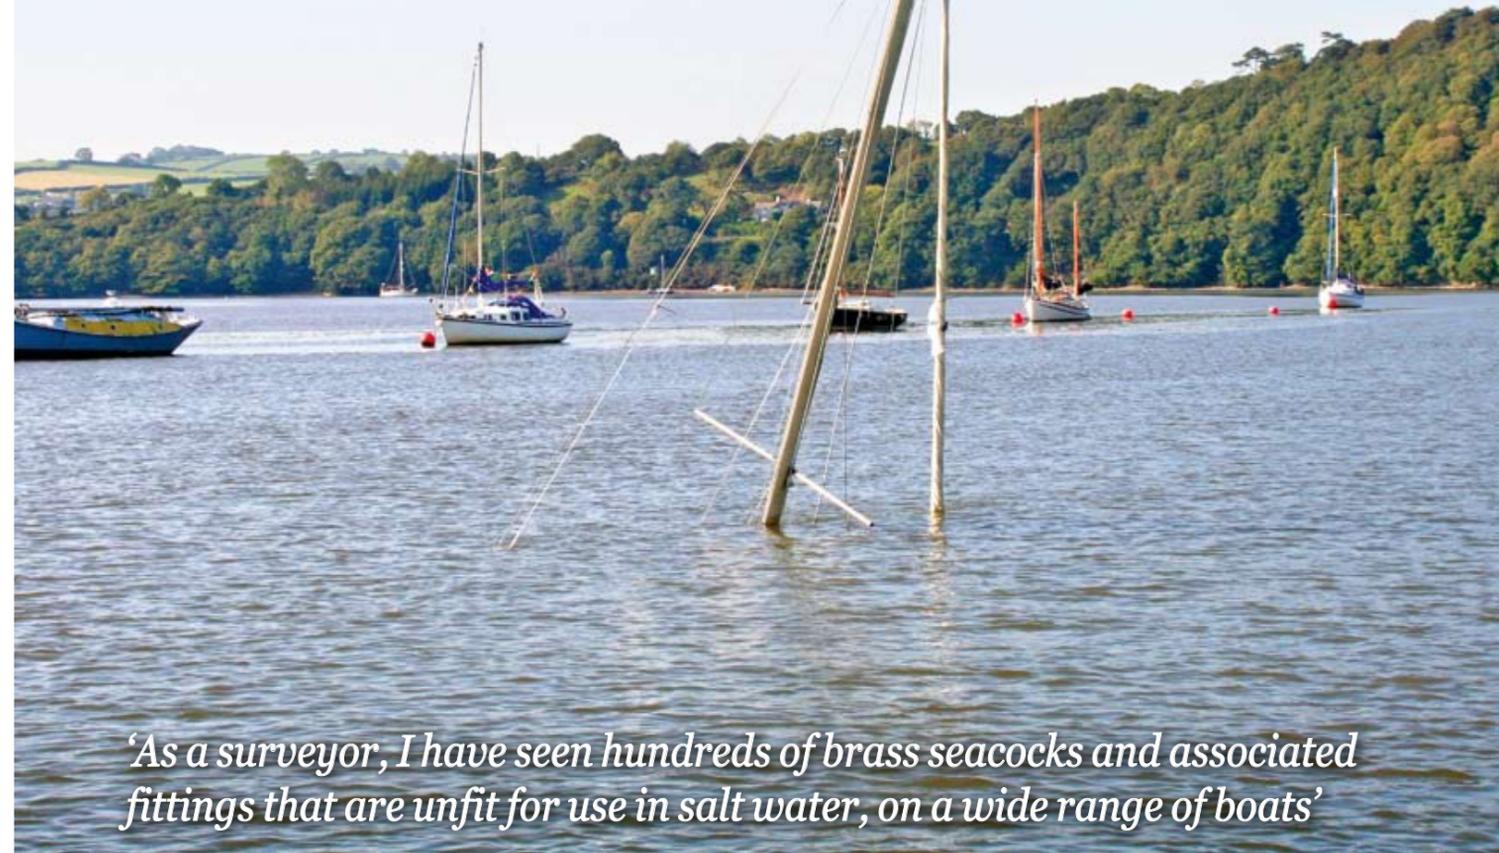
This yacht sank on her mooring on the River Tamar. Thousands of boats with inadequate seacocks are at risk of sharing her fate

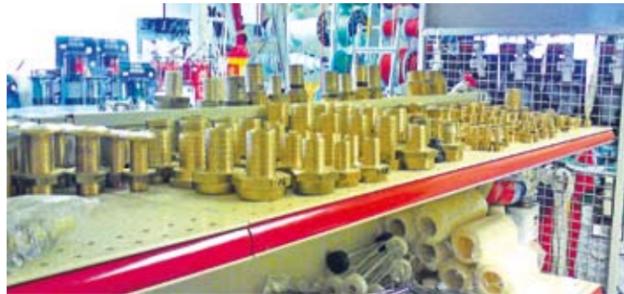
Components are often sold loose. This chandler explains the difference

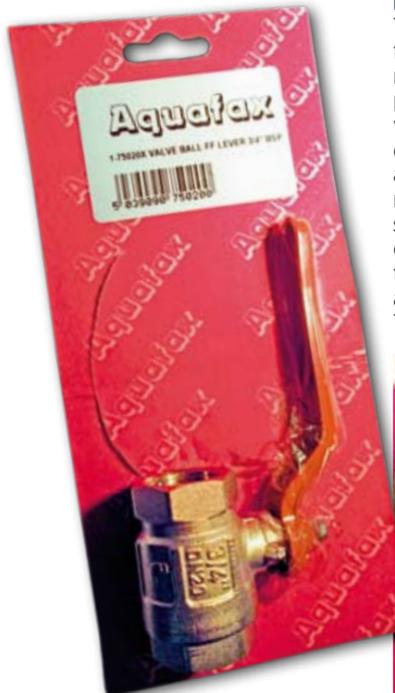
CW617N brass valve – but the marking is on the back of the valve thus not visible in packaging

Buying the right skin fittings and tailpipes is absolutely essential, but what of the valves themselves? The ball valve in the photo show far left is a CW617N brass valve but it is not all it may seem. The marking 'CW617N' is the European designation for ordinary brass with a high zinc content. Ball valves are made in their millions using this material, because they perform so well in fresh water plumbing and piping systems,

but the material is not classed as dezincification-resistant and should not be used in salt water.

To be fair, this ball valve has thick walls and may well last quite a few years if immersed in seawater. But experience suggests that if any electrolytic action is present – and with the proliferation of shore power supply, plus extensive onboard electrical systems, this is common – then the rate of dezincification is rapidly accelerated. That is exactly what nearly sunk *Random Harvest*, and it has also affected the brass ball valve pictured (inset right) The wall of the valve is badly dezincified and has just sheared off. Many boat owners believe the ball valves and associated components in their boats to be made of DZR or bronze, but, in fact, some are ordinary brass alloys – typically containing 40% zinc. The Copper Development Association has set up a UK scheme to mark genuine DZR valves with the designation 'CR' but this is not mandatory.

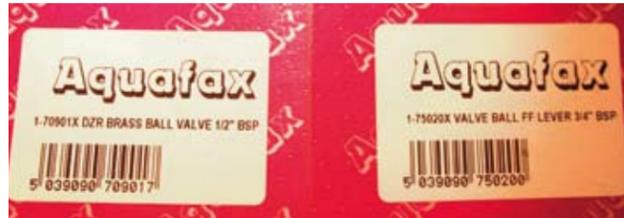
ABOVE: Packaging for ball valves, the DZR brass one is marked but the plain brass one is not

all, with potentially disastrous consequences. I recently bought two tailpipes, as would be used on a typical heads discharge assembly, in a large, well-known chandler's shop. They were shrink-wrapped onto backing cards and the bronze one was described, but the brass one was not marked at all. Both were absolutely identical in appearance and presentation, apart from one little word – if it doesn't actually say 'bronze' or 'DZR', you must assume that it isn't.

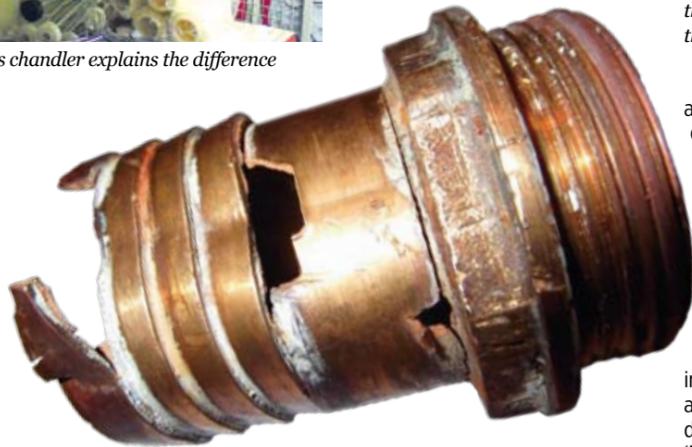
An ordinary brass tailpipe found during the survey of a 10-year-old boat. It was so badly dezincified that the wall simply crumbled under a light tap. The tailpipe was on a cockpit drain always left open. Left like this, it would only be a matter of time before the boat sank.

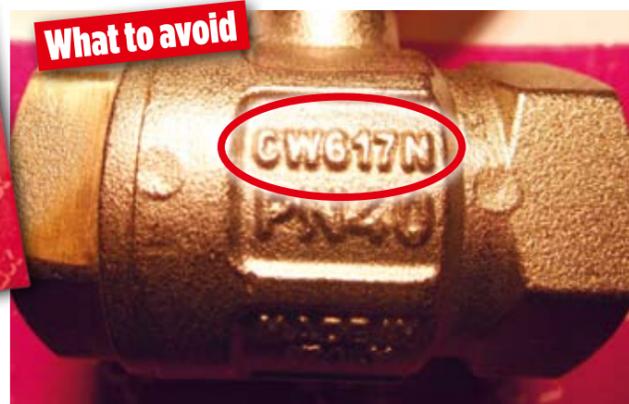
Brass valve removed from packaging and turned over to show marking

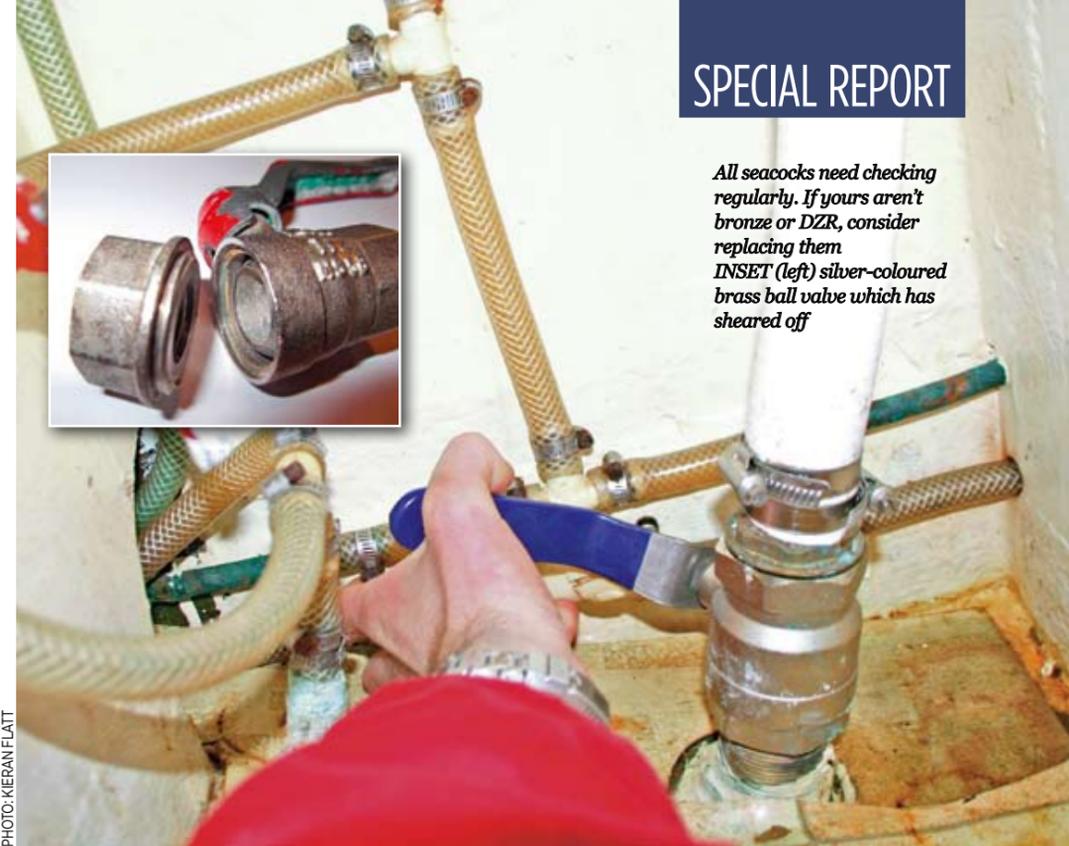
All seacocks need checking regularly. If yours aren't bronze or DZR, consider replacing them
INSET (left) silver-coloured brass ball valve which has sheared off

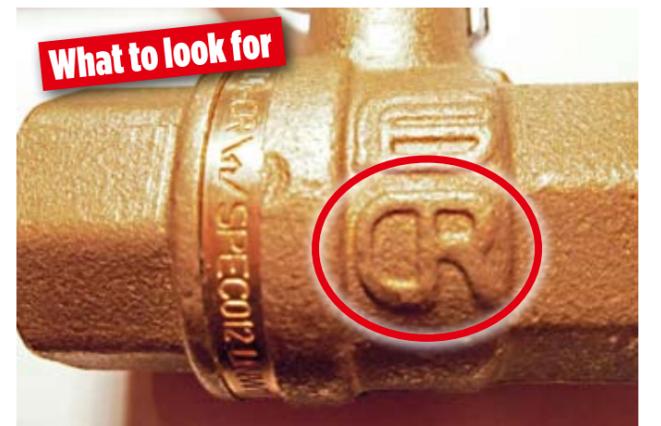
DZR brass ball valve with 'CR' (corrosion-resistant) marking
